Cooperative Lakes Monitoring Program

2014 Data Report for Tamarack Lake, Livingston County

Tamarack Lake, Livingston County

2014 CLMP Results

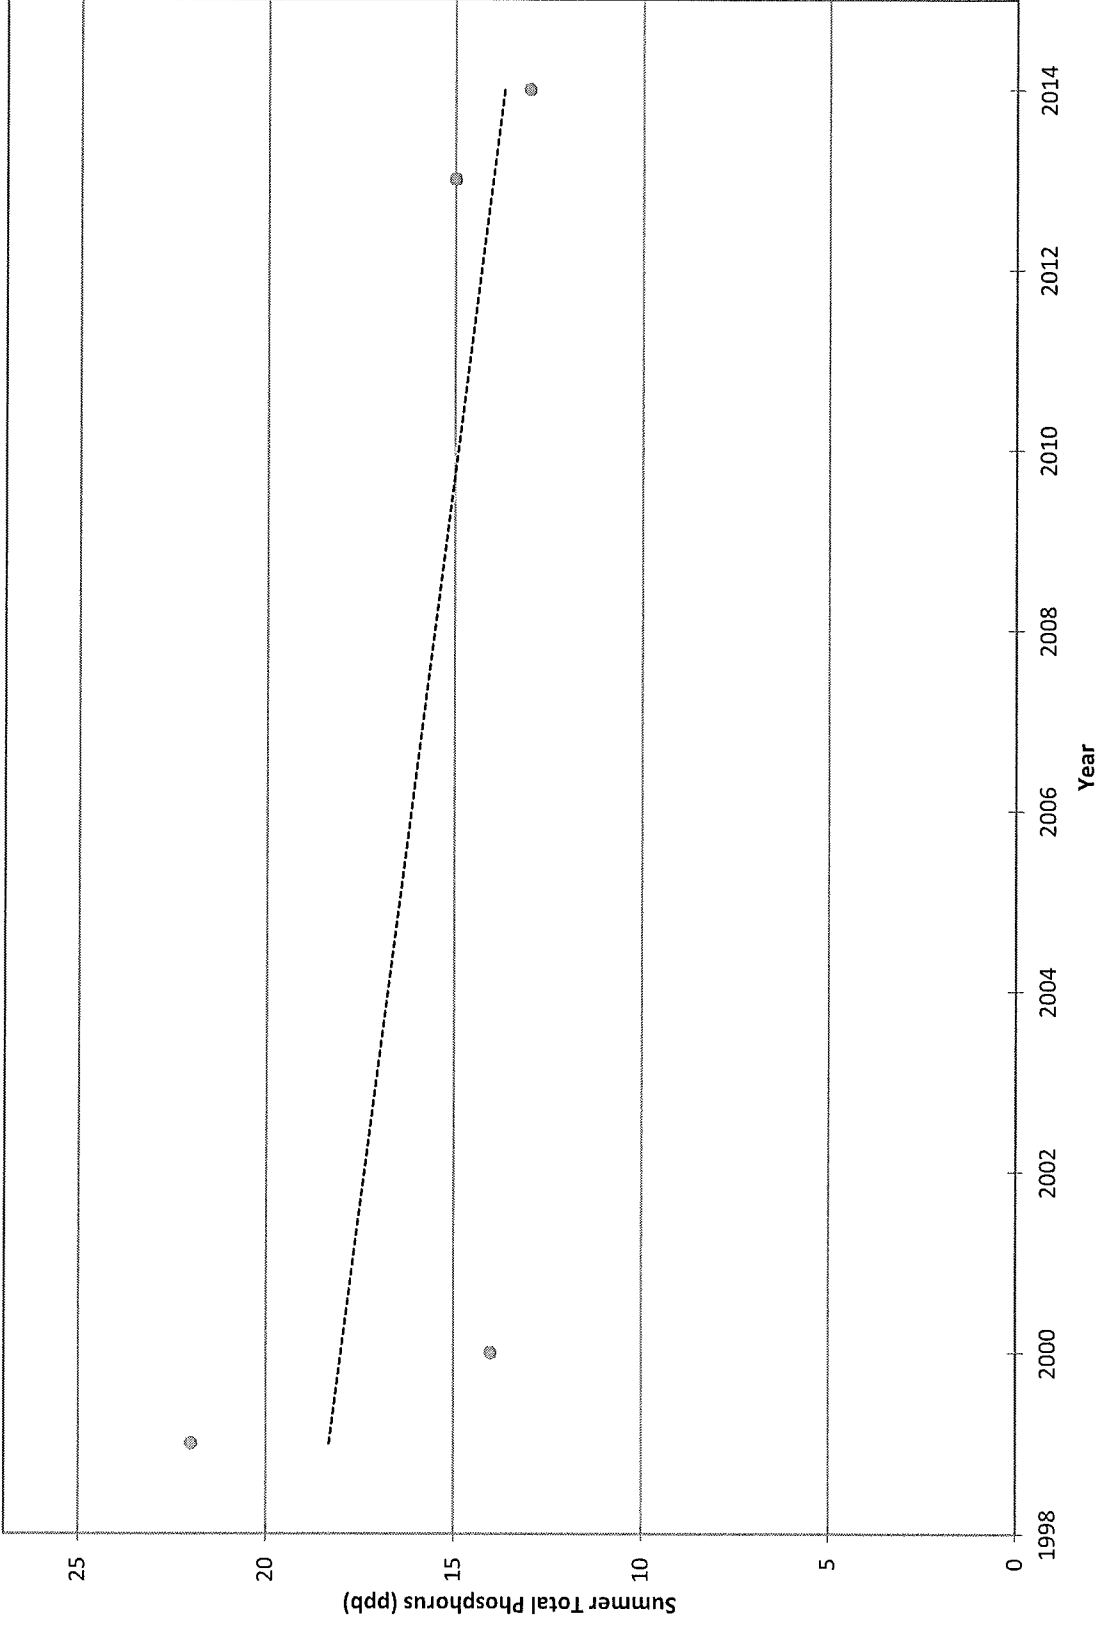
Tamarack Lake (Livingston Co.), 470610

COOPERATIVE LAKES MONITORING PROGRAM
SUMMER TOTAL PHOSPHORUS
