# 2022 Data Report for

## **Tamarack Lake, Livingston County**

Site ID: 470610

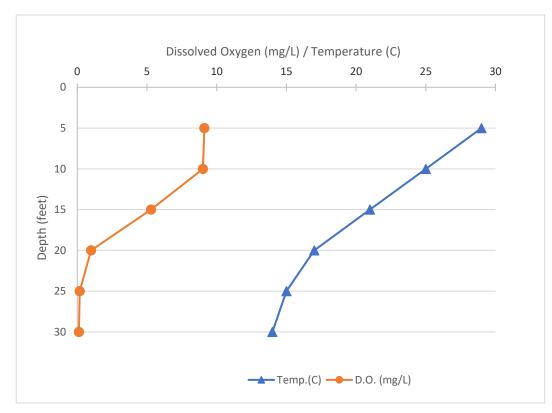
#### **Dissolved Oxygen and Temperature Profile**

County: Livingston Site ID: 470610 Date: 8/14/2013

Depth (ft)	Temp.(C)		D.O. (mg/L)
5		29	9.12
10		25	9.01
15		21	5.3
20		17	0.99
25		15	0.18
30		14	0.12

The lake keeps some dissolved oxygen in the bottom waters through spring and early-summer, but by mid-summer the lake has stratified and the bottom water is devoid of oxygen.
